OV∃X Service Centre

SERVICE SHEET No. 125

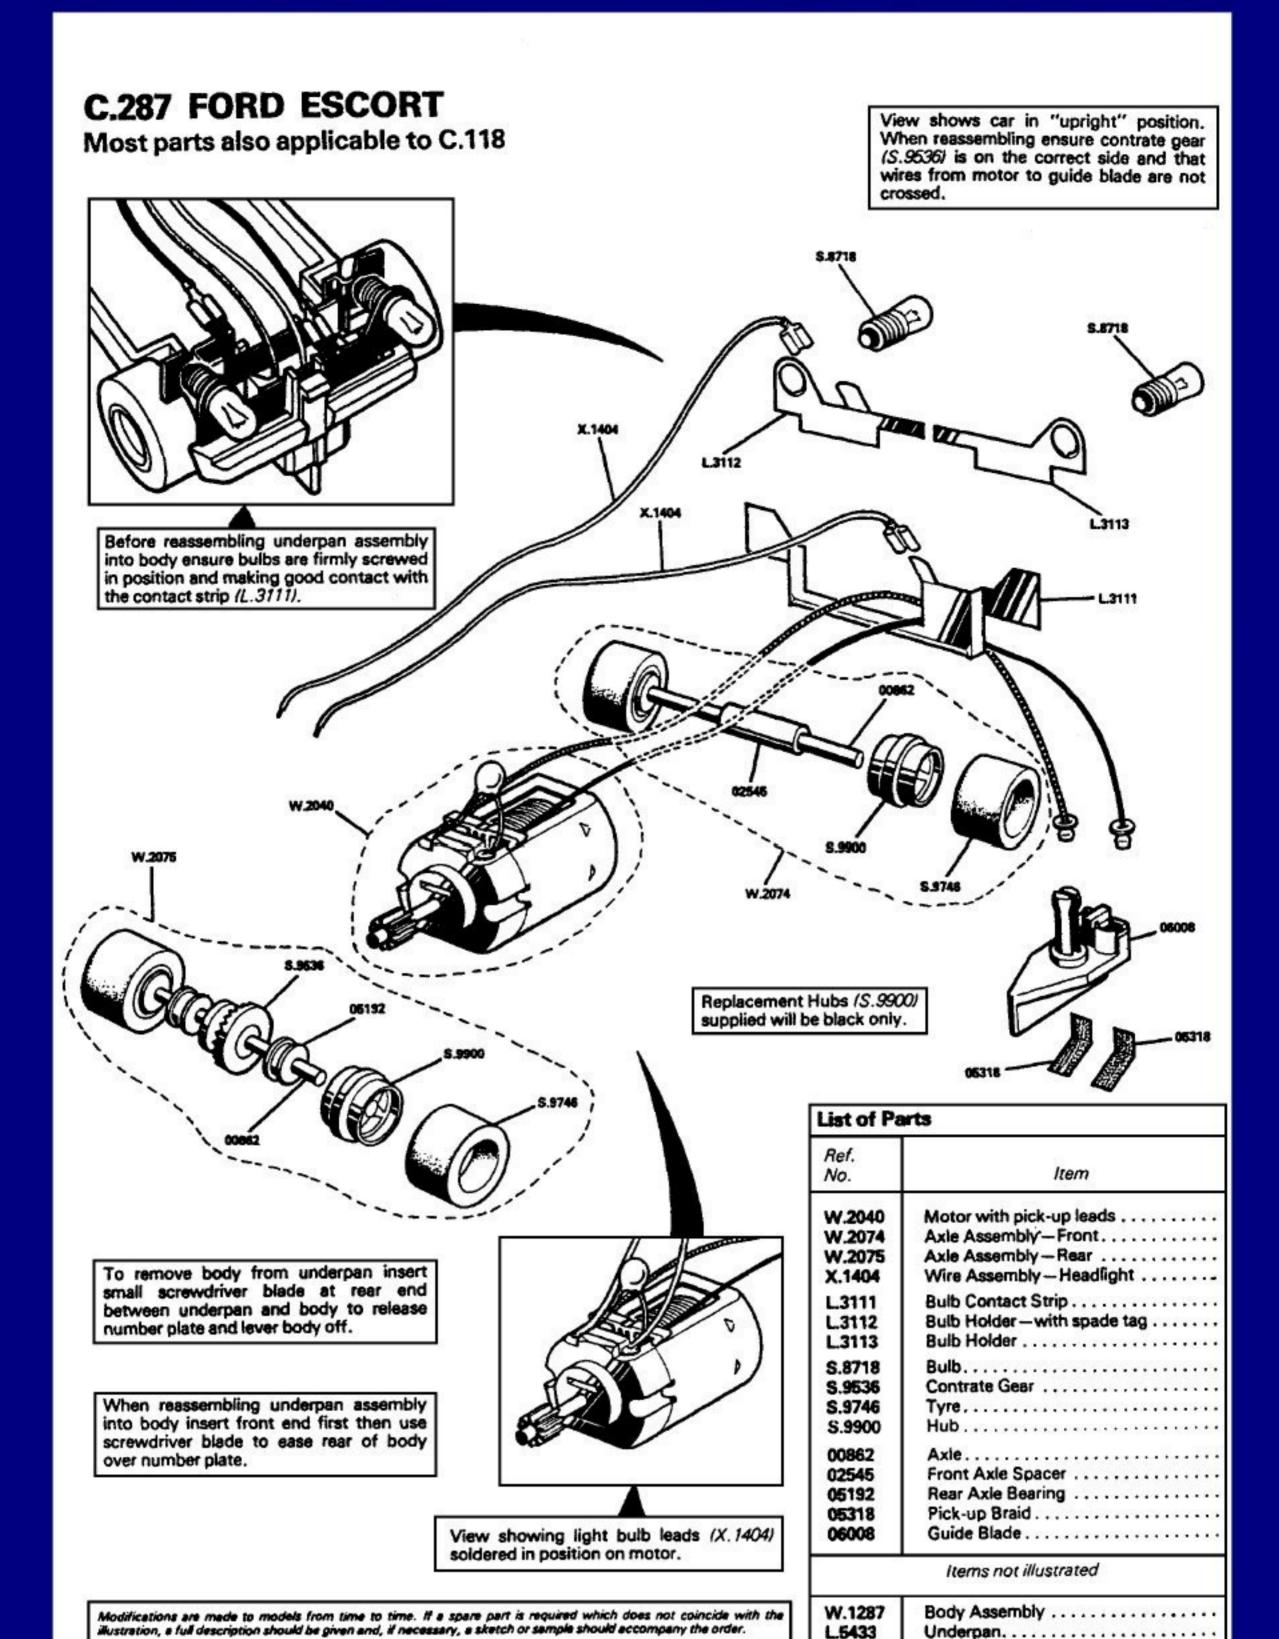
When reassembling ensure contrate gear

(S.9536) is on the correct side and that

wires from motor to guide blade are not

crossed.

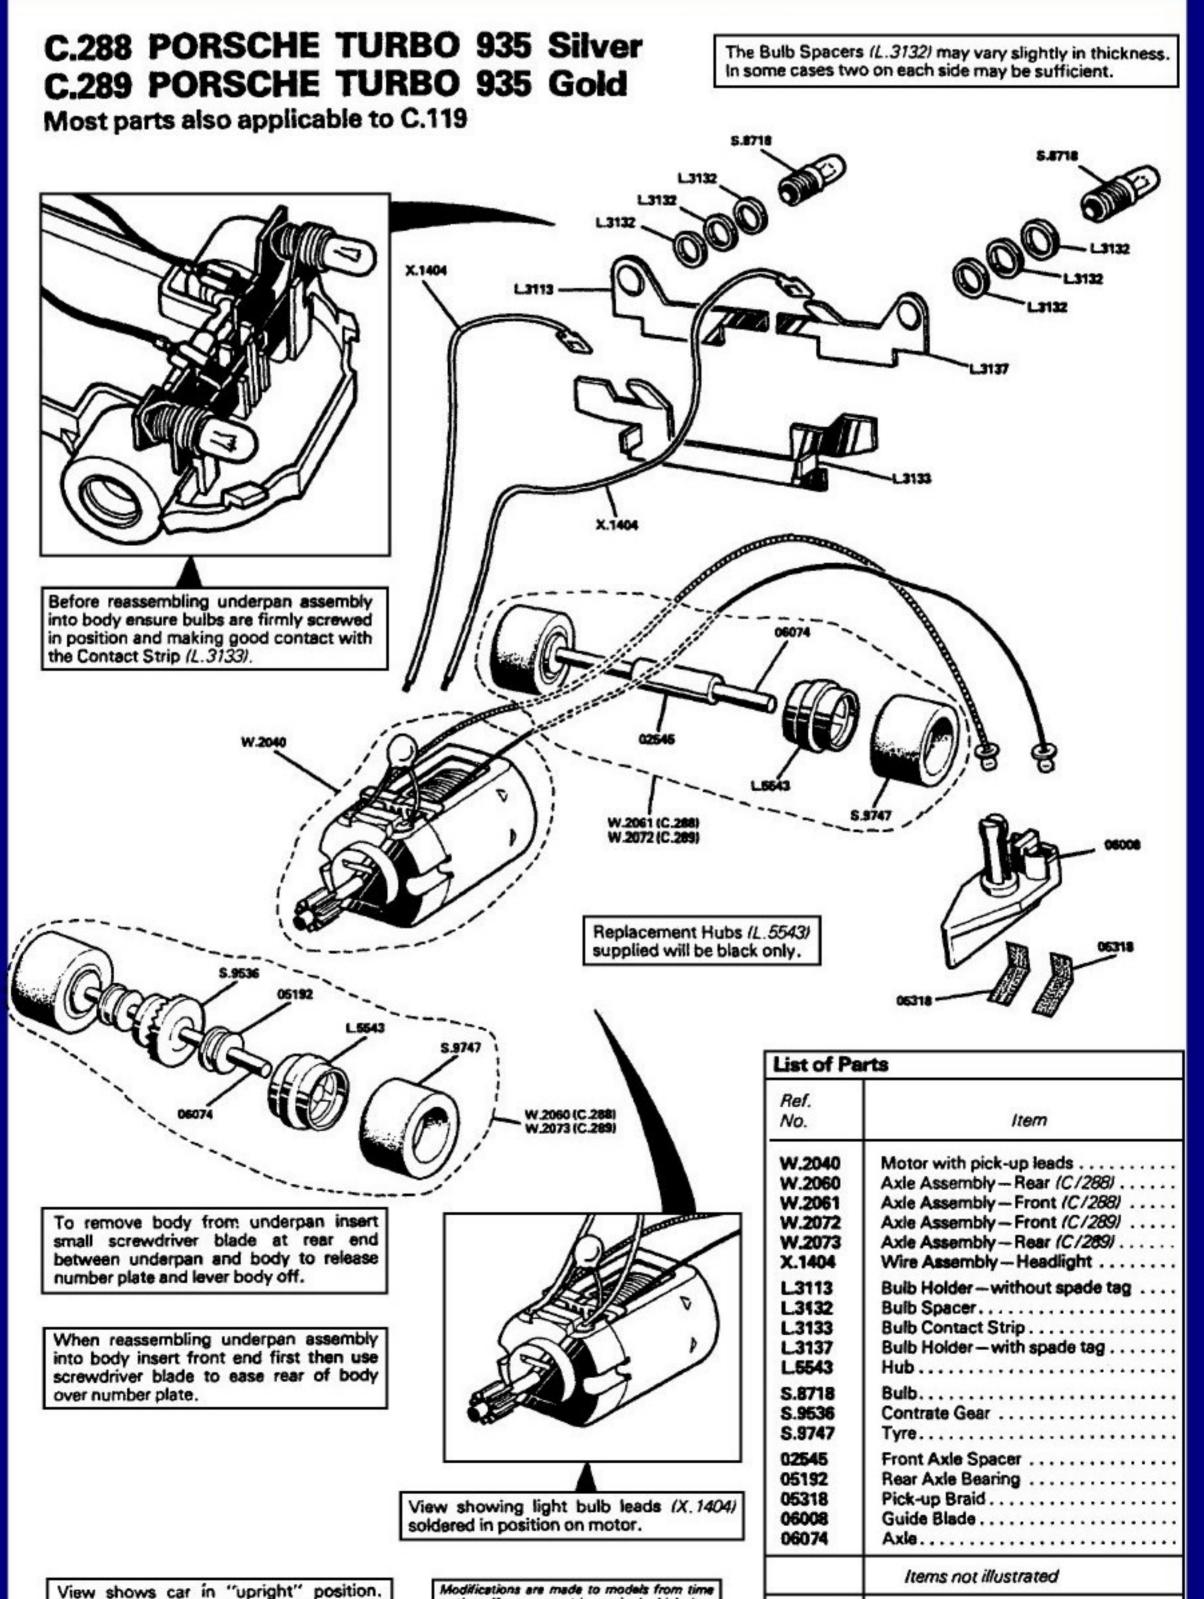
to time. If a spere part is required which does

not coincide with the illustration, a full

description should be given and, if necessary,

a sketch or sample should accompany the

order.

See overleaf for list of spare parts
